## Property Inspection Report

**14603 Breeze Way Court  
Spring, TX 77379**

## PROPERTY INSPECTION REPORT

## Report Identification: SAMPLE REPORT

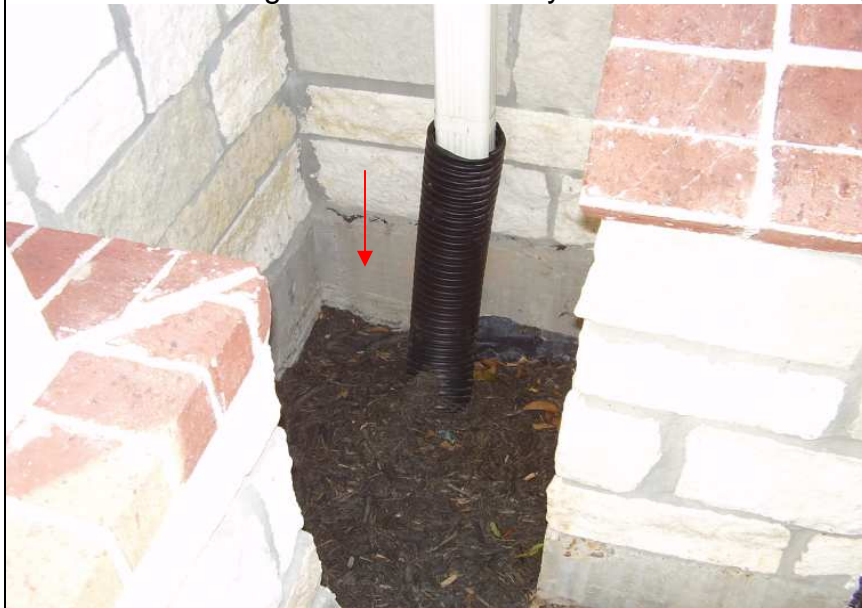
Deficiency - Low soil levels were noted at the S perimeter slab, just to the left of the front entrance door. Soil in this area is conducive to ponding, and should be re-graded to drain away from the foundation (see photo).

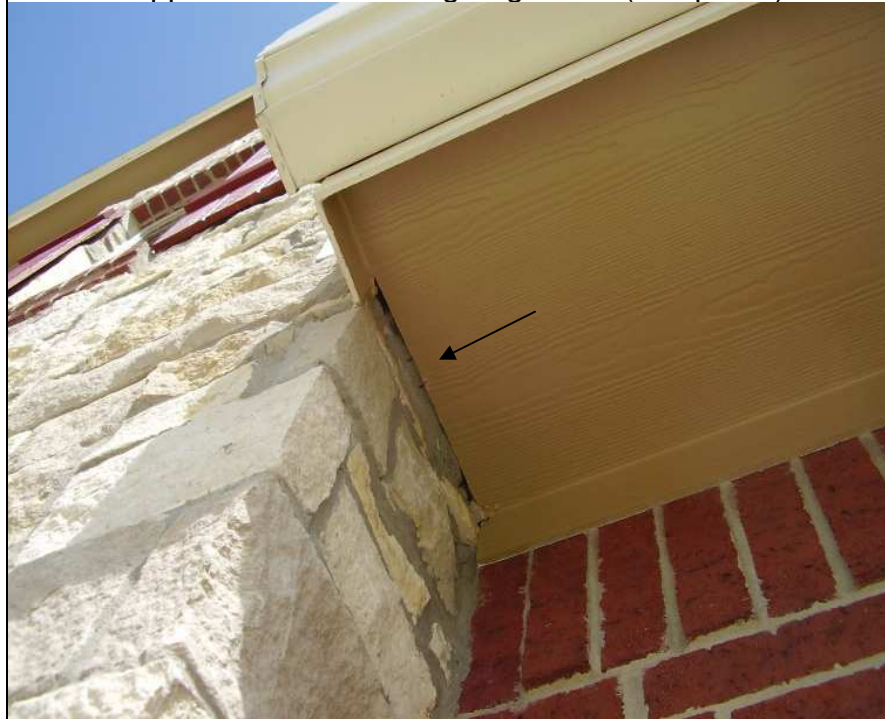
Deficiency - Fill the gap noted in the mortar at the soffit joint to the brick wall at the upper left eave of the garage door (see photo).

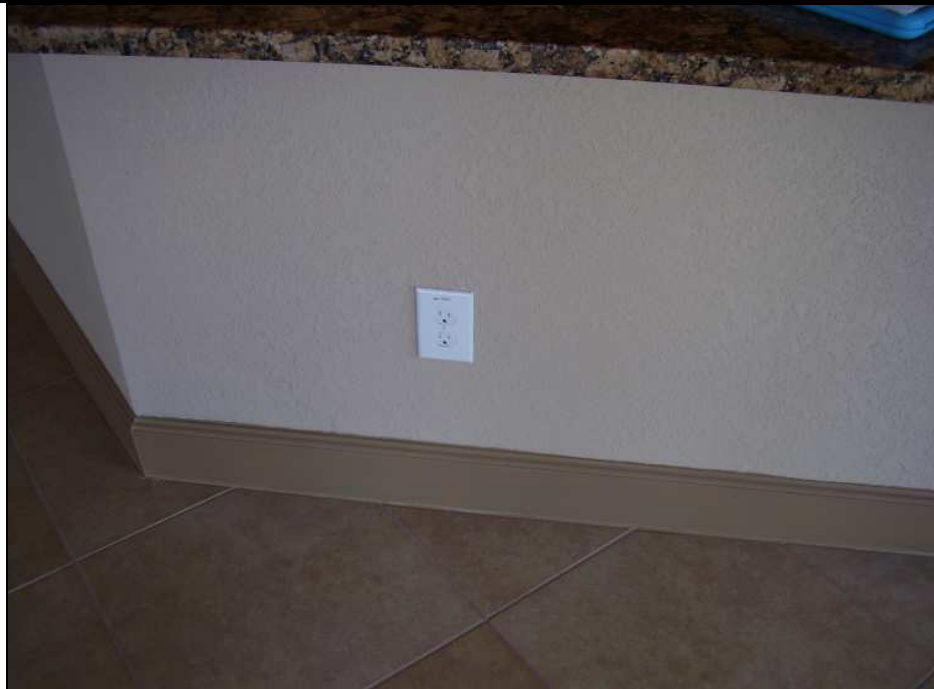
Deficiency - No electrical outlet is allowed to be installed further than 12" below a Breakfast Bar counter top for child safety purposes (and then only if the counter top extends less than 6" from the wall, see photo).

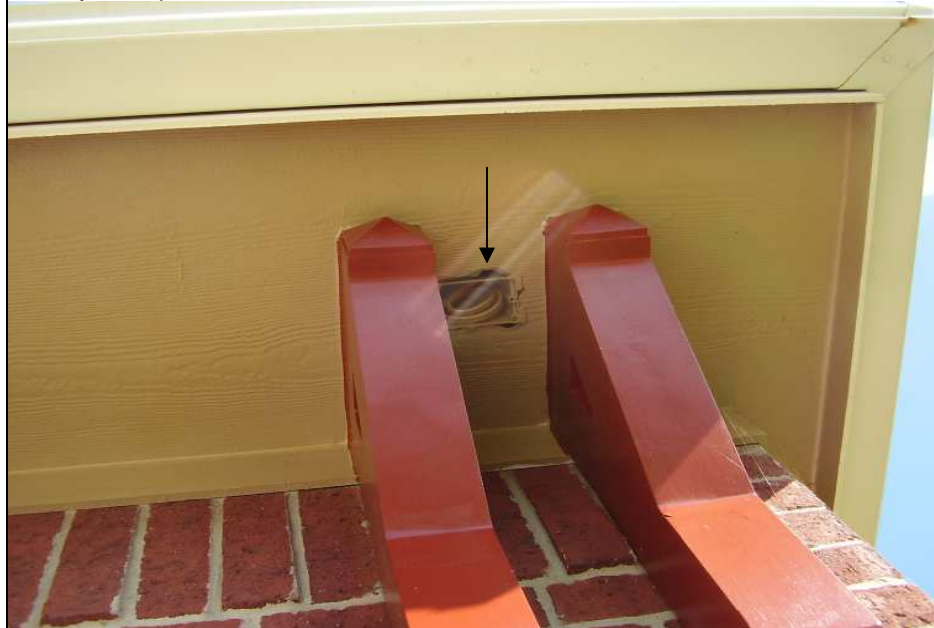
Deficiency - Finish install the electrical outlet at the SE eave of the garage (see photo).

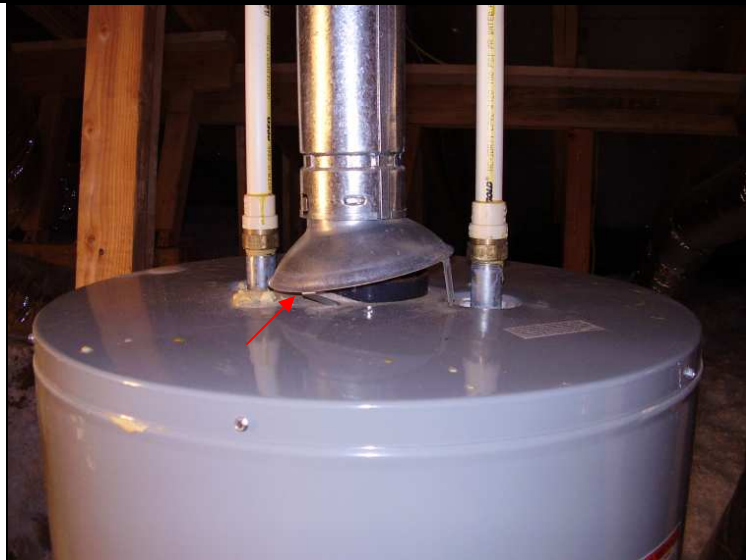
Deficiency - Secure the loose bonnet/exhaust vent pipe to the top of the unit (see photo).
